INDEX OF STANDARD DETAILS

INTRODUCTION

These AHCA Standard Details will be acceptable to the Office of Plans and Construction as a solution to a repair or a construction problem when used as described.

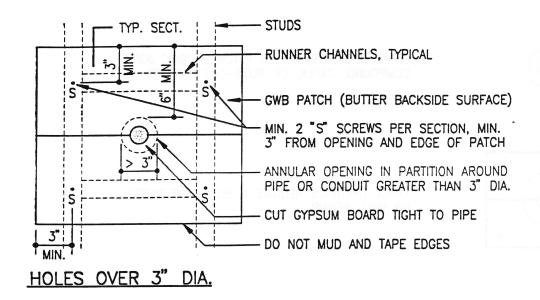
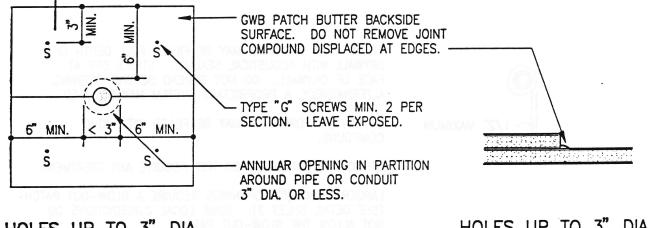
A.H.C.A. STANDARD DETAIL NO. 2

HOLES UP TO 3" DIA.

TYP. SECT.

BLOW-OUT PATCH

ONLY 1 LAYER ON EACH SIDE OF WALL REQUIRED FOR 1 OR 2 HOUR WALLS. BLOW-OUT PATCH IS NOT ACCEPTABLE ON WALLS RATED AT 3 OR 4 HOURS.

- 1. BUTTER ENTIRE BACK SIDE OF PATCH WITH JOINT COMPOUND.
- 2. LEAVE ALL SCREWS EXPOSED.

It was further found that when a larger patch was required, it should be supported by screwing it into the steel framing. We see this indication on Detail 2.

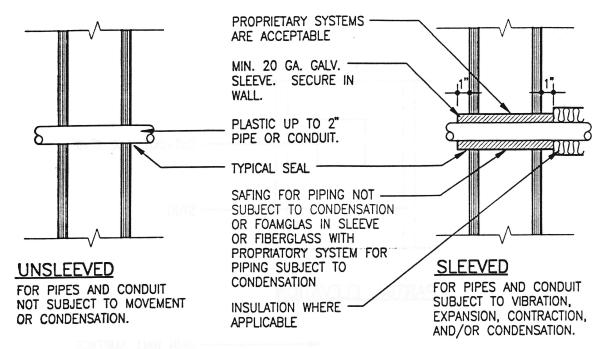
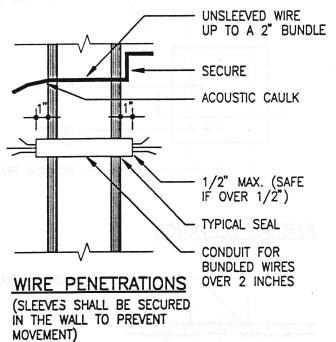
A.H.C.A. STANDARD DETAIL NO. 4

FIRE OR SMOKE WALL PENETRATIONS

PLASTER, DRYWALL, CONCRETE, OR MASONRY

TYPICAL SEAL AS FOLLOWS:

LESS THAN 1/2" = ACOUSTIC CAULK OR DRYWALL

JOINT COMPOUND (NO TAPE)

MORE THAN 1/2" = BLOW-OUT PATCH OR PROPRIETARY SYSTEM.

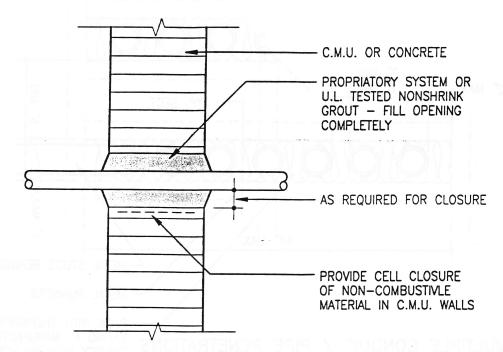
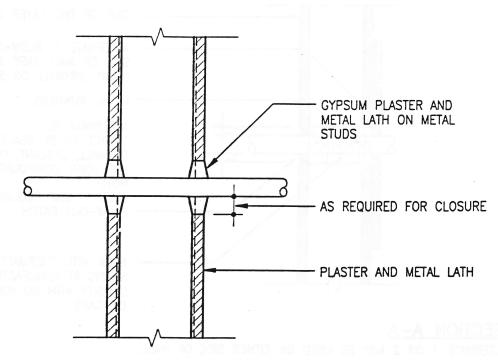
A.H.C.A. STANDARD DETAIL NO. 5

CONCRETE MASONRY UNITS OR SOLID CONCRETE WALLS

GYPSUM PLASTER, METAL LATH AND METAL STUD PARTITIONS

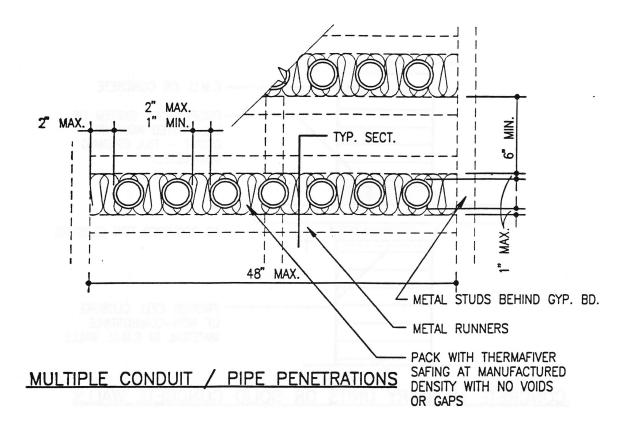
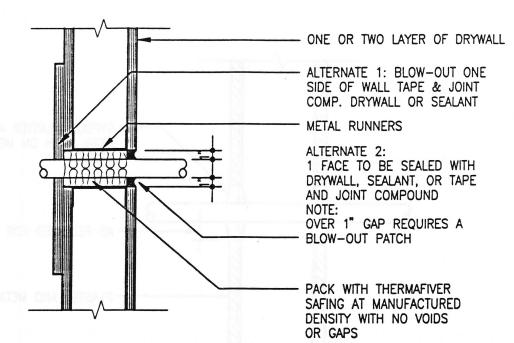
A.H.C.A. STANDARD DETAIL NO. 6

SECTION A-A

ALTERNATE 1 OR 2 MAY BE USED ON EITHER SIDE OF WALL. ONE SIDE OF PENETRATION MAY REMAIN OPEN.

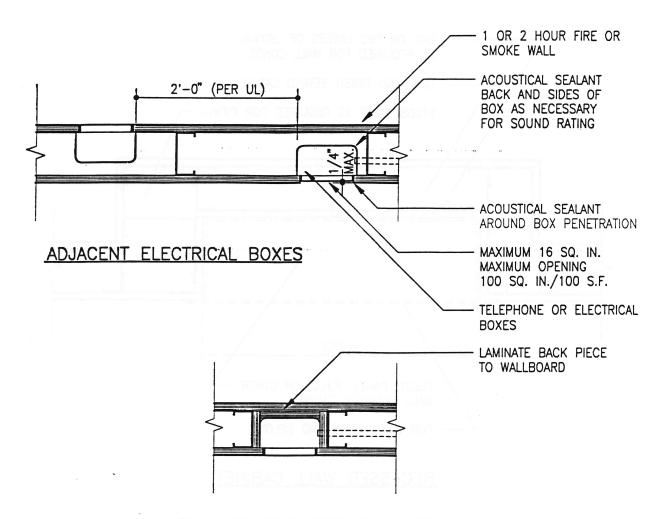
A.H.C.A. STANDARD DETAIL NO. 7

SHALLOW FIVE SIDE BOX DETAIL

REQUIRED WHERE BOX EXCEEDS 16 SQ. INCHES OR AGGREGATE OF BOXES EXCEEDS 100 SQ. IN./

ELECTRICAL JUNCTION BOXES

WHEN A METALLIC JUNCTION BOX FOR ELECTRICAL RECEPTACLES OR SWITCHES IS CONTAINED WITHIN A RATED WALL OF GYPSUM DRYWALL CONSTRUCTION AND AN OPENING IS PROVIDED FOR THE BOX IN THE SURFACE OF THAT WALL, THE AREA OF THE OPENING MAY NOT EXCEED 16 SQUARE INCHES, UNLESS THE JUNCTION BOX IS ENCLOSED BY A "5-SIDED BOX" (SEE APPROVED DETAILS).

THE AGGREGATE AREA OF ALL SUCH JUNCTION BOXES IN A RATED WALL NOT ENCLOSED BY "5-SIDED BOXES" DESCRIBED ABOVE SHALL NOT EXCEED 100 SQUARE INCHES IN 100 SQUARE FEET OF WALL AREA AS MEASURED FROM FLOOR TO STRUCTURAL DECK OR RATED MEMBRANE.

JUNCTION BOXES WITH OPENINGS ON OPPOSITE FACES OF RATED WALLS SHALL HAVE A HORIZONTAL SEPARATION OF 24 INCHES AS A MINIMUM, REGARDLESS OF BOX SIZE, UNLESS ENCLOSED BY "5-SIDED BOXES."

LOCATIONS OF STUDS DO NOT HAVE ANY BEARING ON THE ABOVE REQUIREMENTS, NOR DOES THE USE OF MINERAL WOOL FIRE SAFING ALTER THESE REQUIREMENTS.

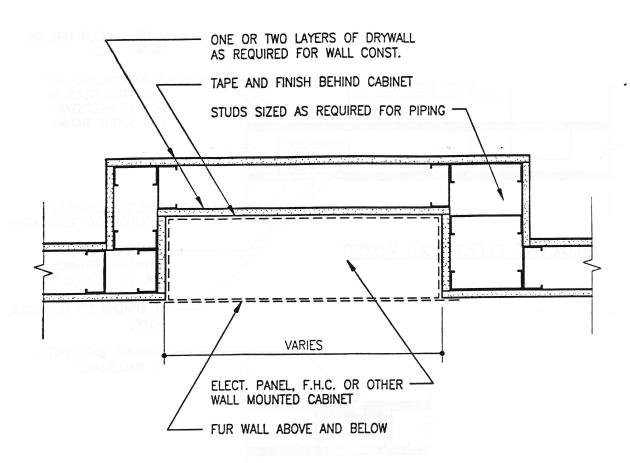
A.H.C.A. STANDARD DETAIL NO. 8

RECESSED WALL CABINET

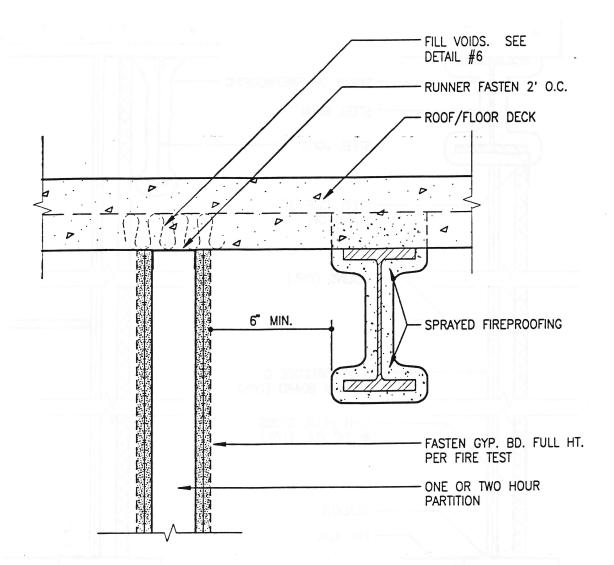
A.H.C.A. STANDARD DETAIL NO. 9

SMOKE & RATED PARTITION ADJACENT TO BEAM

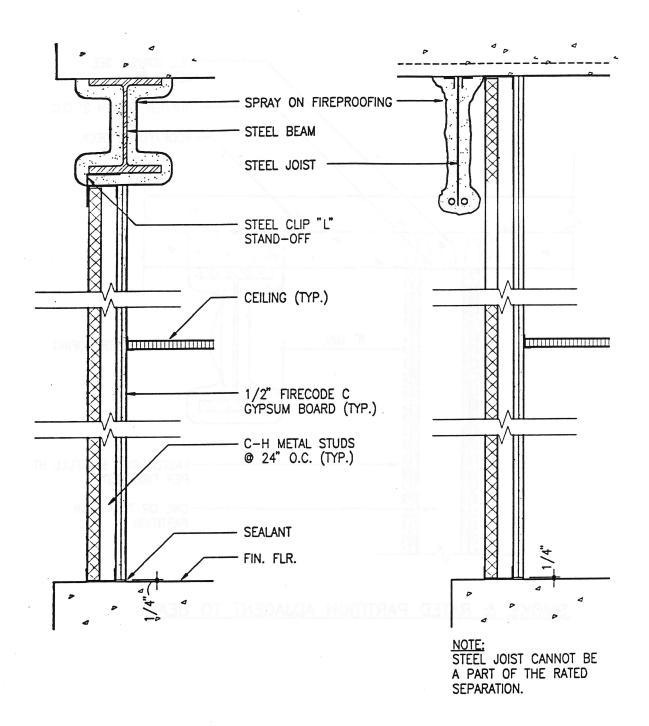
A.H.C.A. STANDARD DETAIL NO. 10

TWO — HOUR RATED SHAFT WALLS SPRAY FIREPROOFING MUST HAVE 2—HOUR THICKNESS OR GREATER.

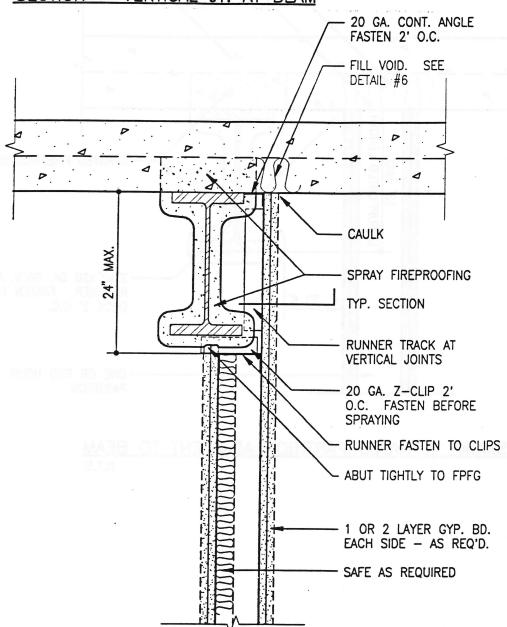
A.H.C.A. STANDARD DETAIL NO. 11

SECTION - VERTICAL JT. AT BEAM

DETAIL - RATED PARTITION UNDER BEAM

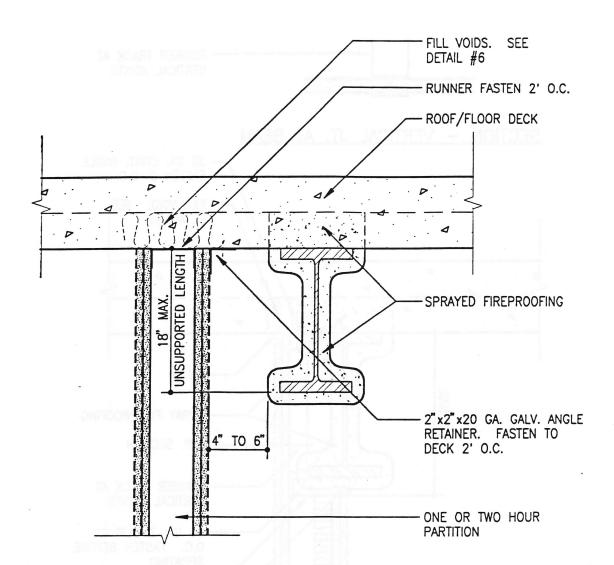
A.H.C.A. STANDARD DETAIL NO. 12

SMOKE & RATED PARTITION ADJACENT TO BEAM N.T.S.

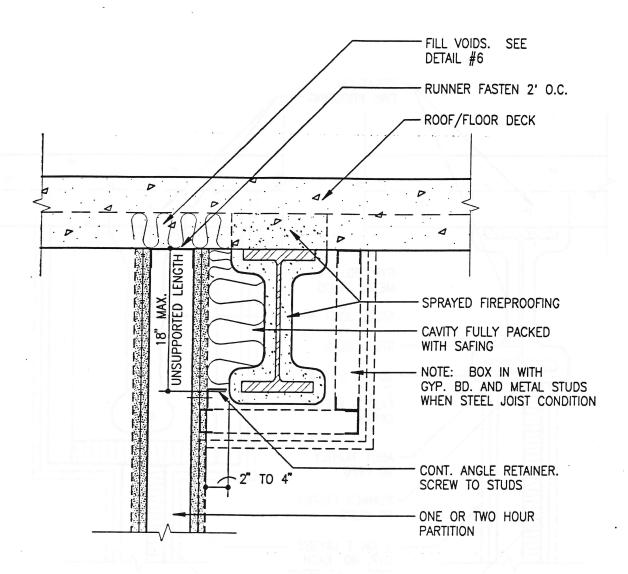
A.H.C.A. STANDARD DETAIL NO. 13

SMOKE & RATED PARTITION ADJACENT TO BEAM (STRUCTURALLY BOXED IN)

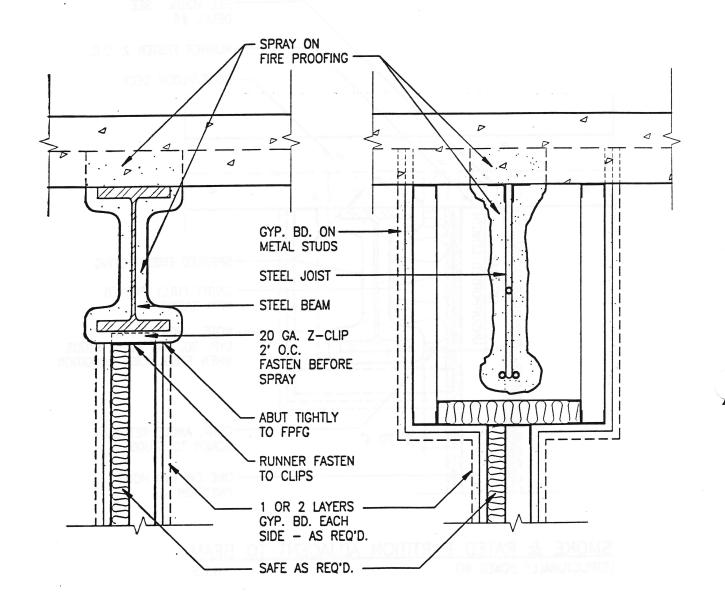
A.H.C.A. STANDARD DETAIL NO. 14

RATED PARTITION UNDER BEAM N.T.S.

RATED PARTITION UNDER JOIST N.T.S.

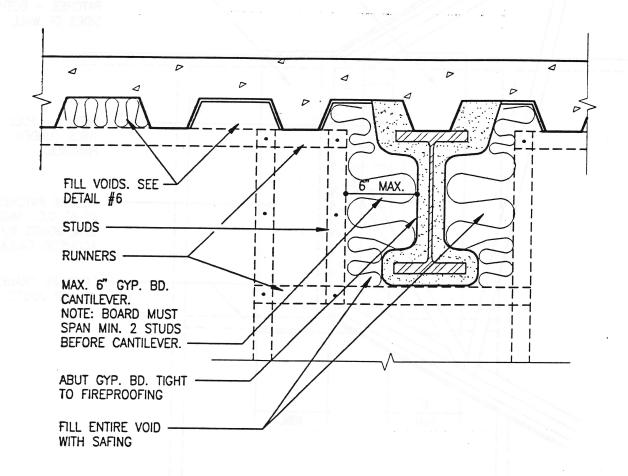
A.H.C.A. STANDARD DETAIL NO. 15

<u>DETAIL -- RATED WALL PERPENDICULAR TO BEAM N.T.S.</u>

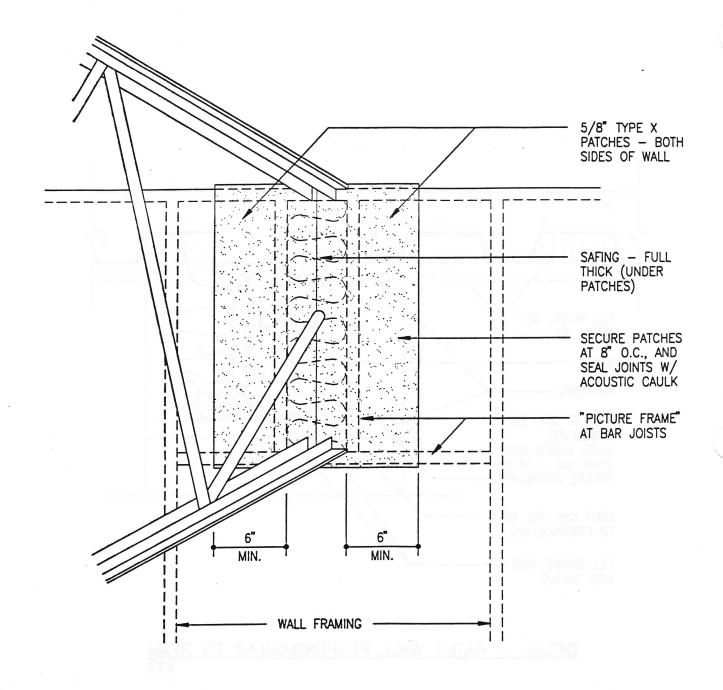
BLOW OUT PATCH BAR JOIST PENETRATION OF A RATED WALL N.T.S.

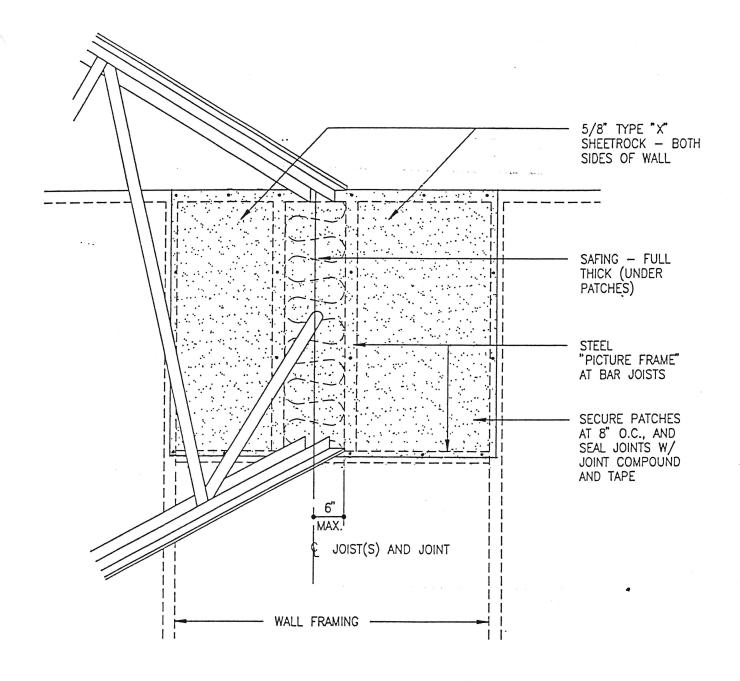
A.H.C.A. STANDARD DETAIL NO. 17

FLUSH WALL CONSTRUCTION BAR JOIST PENETRATION OF A RATED WALL N.T.S.

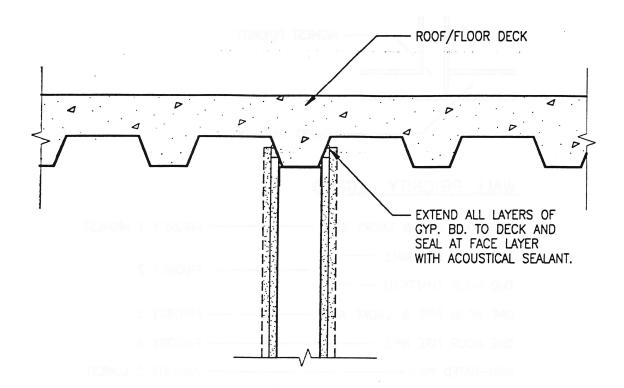
A.H.C.A. STANDARD DETAIL NO. 19

TYPICAL RATED WALL PARALLEL TO DECK
N.T.S.

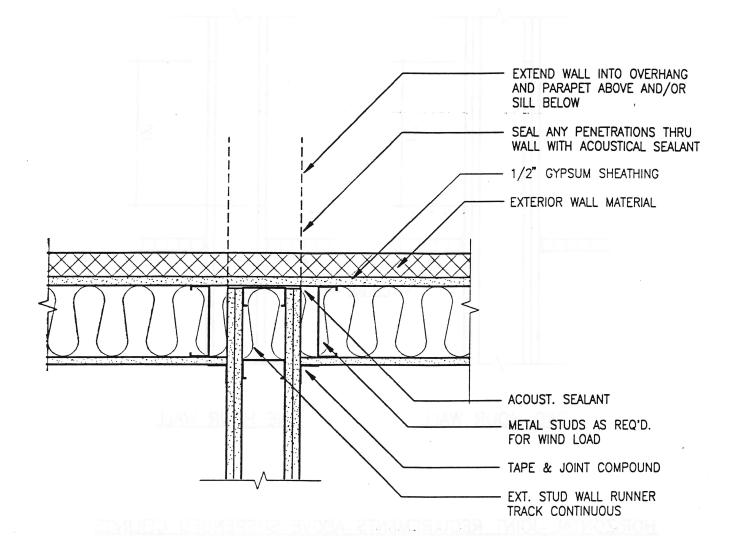
Δ	HCA	STAND	ARD	DETAIL	NO	21
$\boldsymbol{\Lambda}$		SIMIL		DEIAL	IVO.

PLAN VIEW - FIRE AND/OR SMOKE WALL AT EXTERIOR WALL

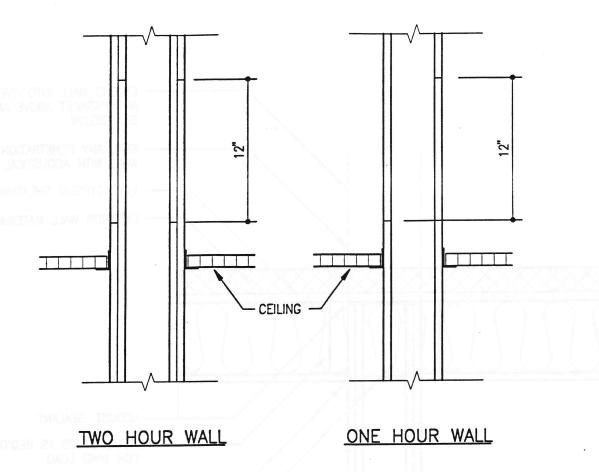
A.H.C.A. STANDARD DETAIL NO. 22

HORIZONTAL JOINT REQUIREMENTS ABOVE SUSPENDED CEILINGS

- 1. JOINTS MAY BE OPPOSITE IF SAFEING IS USED IN CAVITY. REF: CEG 8-11-83 CEG 5-9-84
- 2. JOINTS IN FINISH LAYER TO RECEIVE TAPE AND JOINT COMPOUND

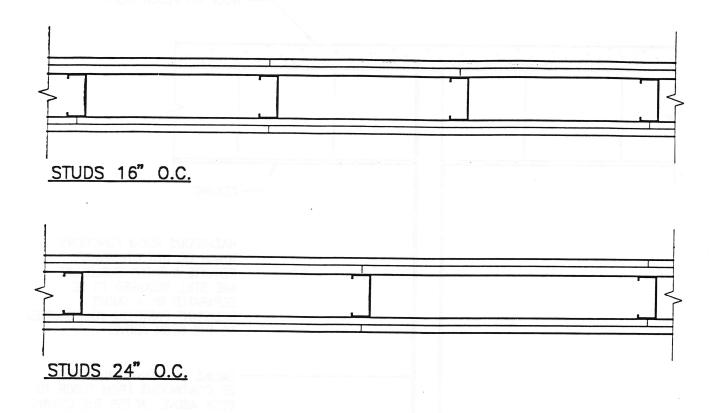
A.H.C.A. STANDARD DETAIL NO. 23

PLAN VIEW - TYPICAL JOINT REQUIREMENTS 2 HOUR WALL

- 1. GYPSUM BOARD APPLIED VERTICALLY
- 2. JOINTS IN FINISH LAYER TO RECEIVE TAPE AND JOINT COMPOUND

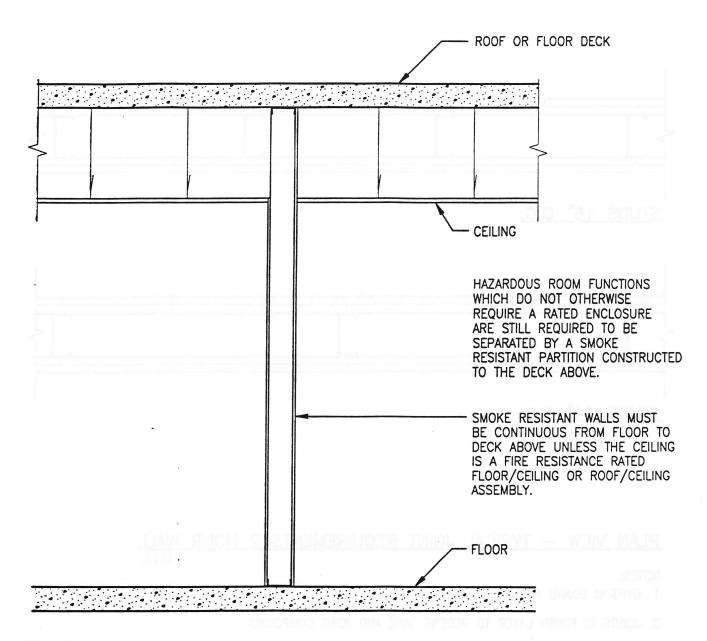
A.H.C.A. STANDARD DETAIL NO. 24

SECTION

SMOKE RESISTANT WALLS AND HAZARDOUS FUNCTION SEPARATION WALLS AS DEFINED IN STANDARD BUILDING CODE 409.1.5.

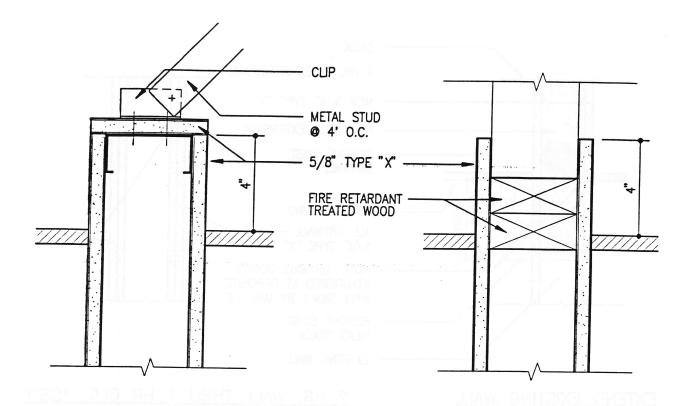
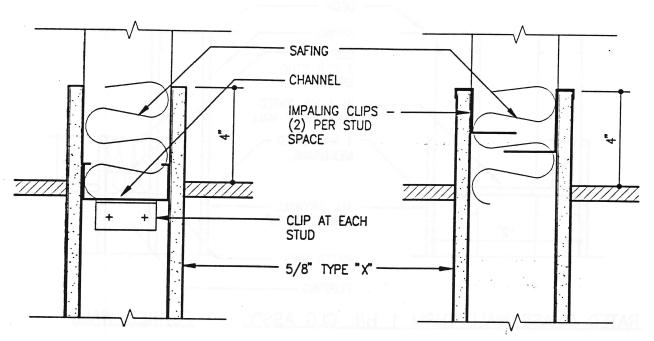
A.H.C.A. STANDARD DETAIL NO. 25

RATED PARTITION PENETRATION OF 1-HR RATED CEILING ASSEMBLY

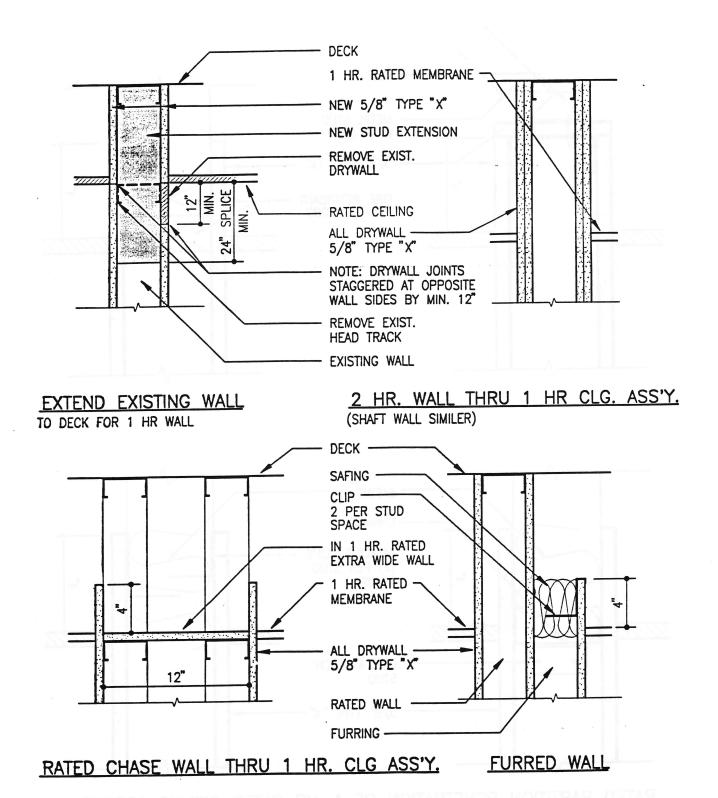
A.H.C.A. STANDARD DETAIL NO. 26

PARTITION PENETRATION OF 1 HR. RATED MEMBRANE N.T.S.

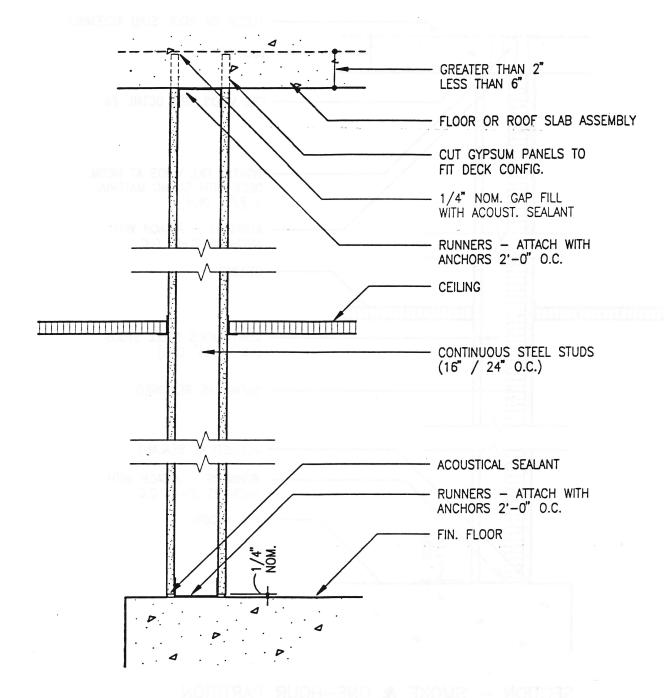
A.H.C.A. STANDARD DETAIL NO. 27

SECTION — SMOKE & ONE—HOUR PARTITION (PERPENDICULAR TO DECK) N.T.S.

TEST REF: T-3362-OSU T-1174-OSU GA-WP-1200

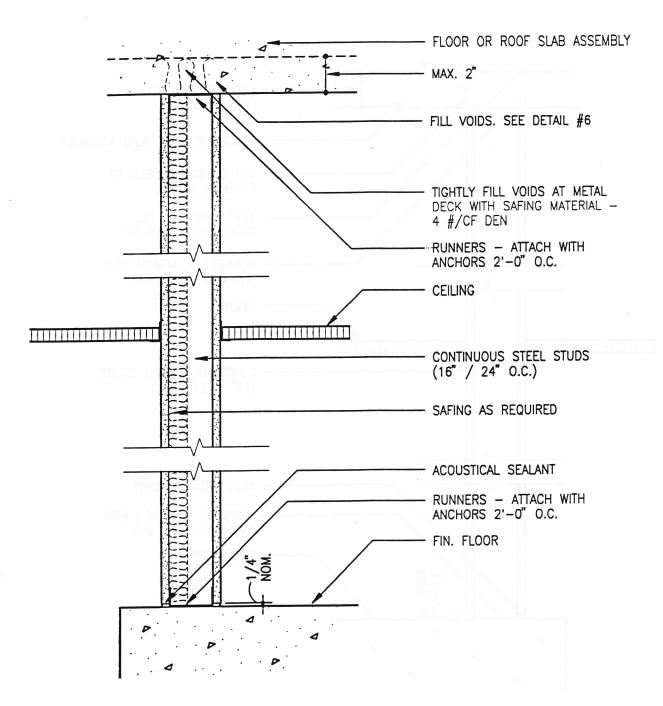
A.H.C.A. STANDARD DETAIL NO. 28

<u>SECTION - SMOKE & ONE-HOUR PARTITION</u> (PERPENDICULAR TO DECK) N.T.S.

TEST REF: T-3362-OSU T-1174-OSU GA-WP-1200

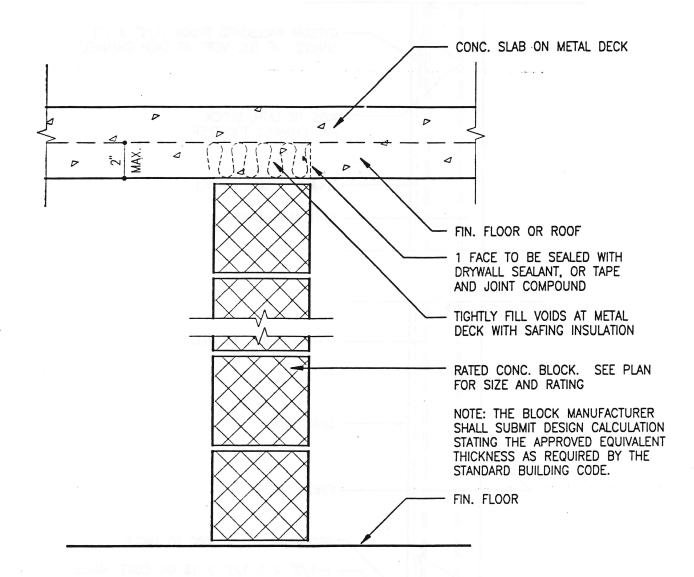
A.H.C.A. STANDARD DETAIL NO. 29

WALL SECTION — TYP. RATED BLOCK WALL FIRE OR SMOKE
N.T.S.

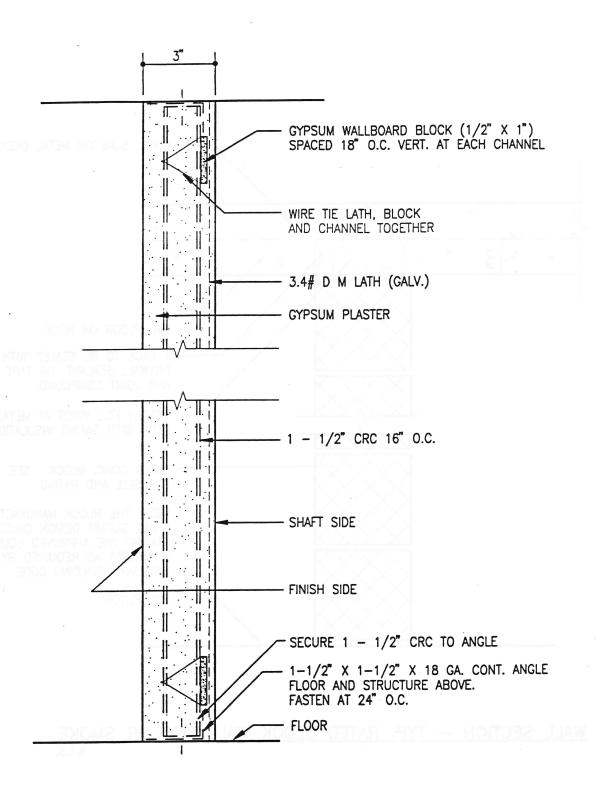
A.H.C.A. STANDARD DETAIL NO. 30

2 HOUR PLASTER SHAFTWALL MAXIMUM HEIGHT 18'-0"

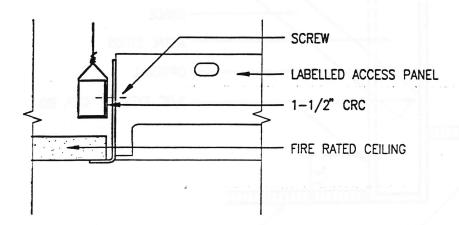
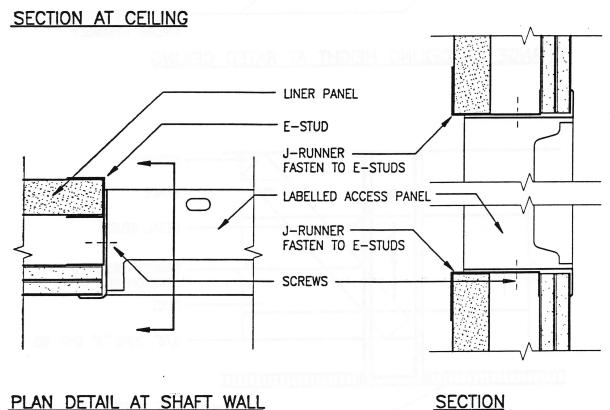
A.H.C.A. STANDARD DETAIL NO. 31

ACCESS PANEL INSTALLATION N.T.S.

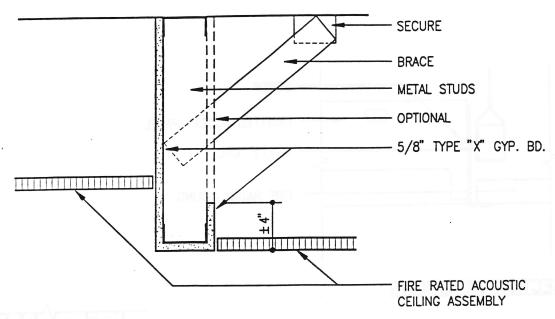
CHANGE OF CEILING HEIGHT AT RATED CEILING

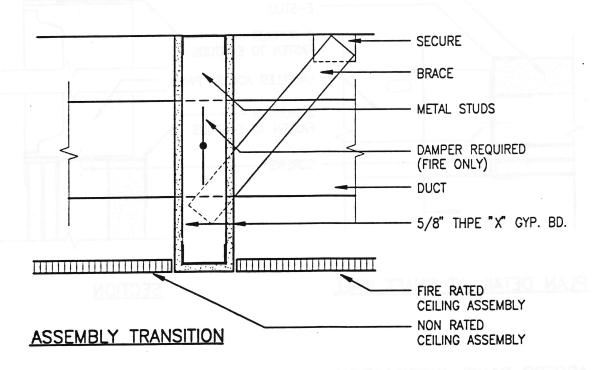
A.H.C.A. STANDARD DETAIL NO. 32

BULKHEAD AT 1 HR. RATED CEILING ASS'Y.

NOTE: 2 LAYERS 5/8" TYPE "X" DRYWALL AT 2 HOUR RATED CEILING ASSEMBLY

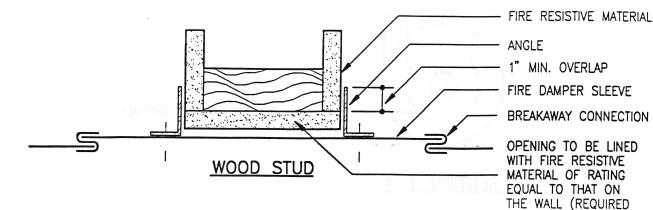
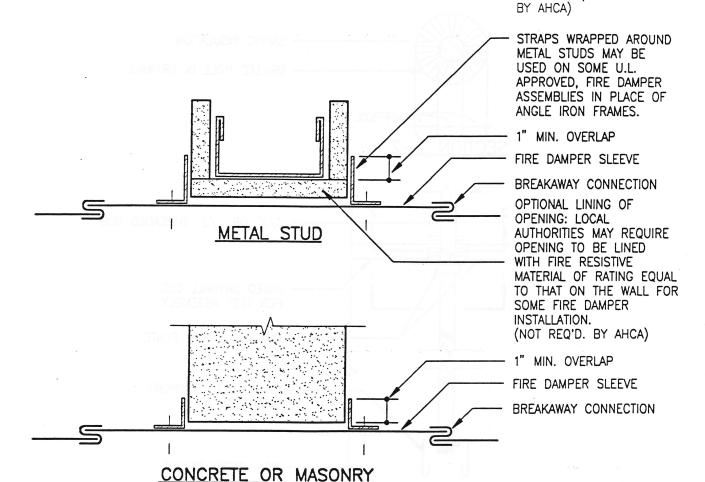
DAMPER SLEEVE INSTALLATION

NOTE:
SPECIFIC FRAMING REQUIREMENTS OF OPENINGS
SHOULD BE PROVIDED IN THE ARCHITECTURAL
AND STRUCTURAL DRAWINGS THAT ARE SUBMITTED
FOR BUILDING PERMITS.

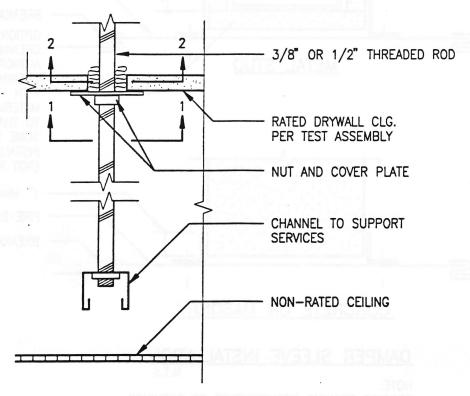
A.H.C.A. STANDARD DETAIL NO. 34

SECTION 1-1

PENETRATION IN RATED CEILING
N.T.S.
